Subject: Aquaculture Compliance Evaluation Inspection at Bedrock Ranch, NPDES Permit Number  
IDG130119

# **NPDES Aquaculture Compliance Evaluation Inspection Report**

**Bedrock Ranch**

**Permit Number: IDG130119  
Inspection Date: February 12, 2020**

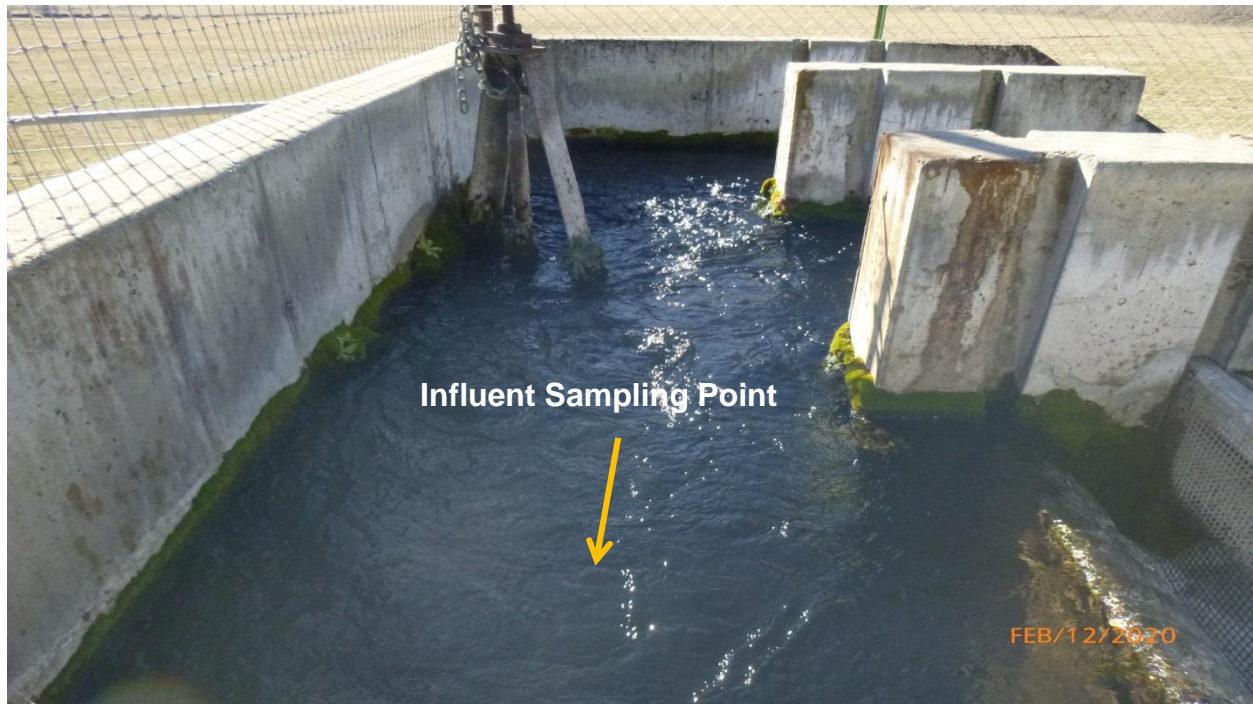
Photograph 1. Upper raceway head ditch - influent sampling point, facing west.

Influent water quality (WQ) parameters of TSS and TP are measured through the collection of composite samples taken at the upper raceway head ditch and consist of a minimum of four grab samples taken at 30 minute intervals or greater.

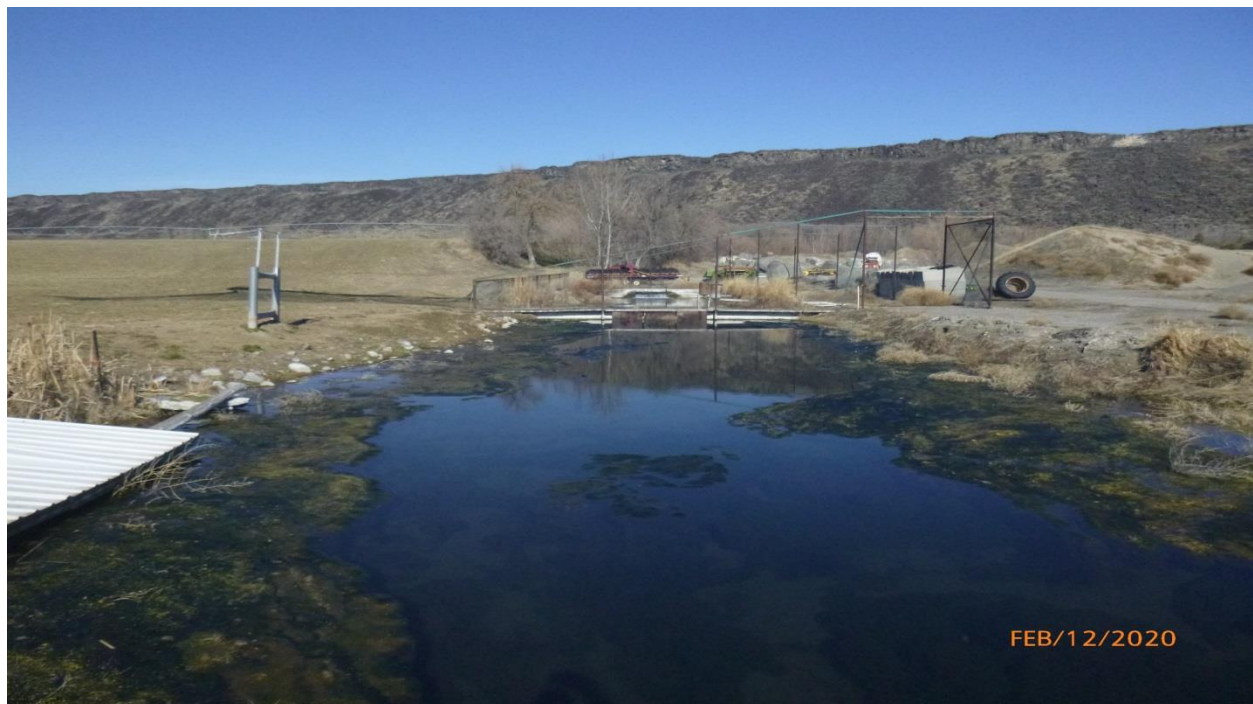
Photograph 3. Earthen pond #5 and FFSB, facing north.

Effluent WQ parameters of TSS and TP are measured through the collection of composite samples and consist of a minimum of four grab samples taken at 30 minute intervals or greater. Because both earthen ponds are not in production, they are essentially an extension of the receiving water and effluent compliance samples could be collected anywhere downstream of the concrete raceways. Mr. Standal is currently electing to collect effluent samples at the discharge point of the FFSB associated with earth pond #5, which is a representative location according to current facility operations. If production were to resume on the second earthen pond (#6), Mr. Standal would need to adjust effluent sampling accordingly, which would ensure that effluent samples were continuing to be collected just prior to being discharged into the receiving water.

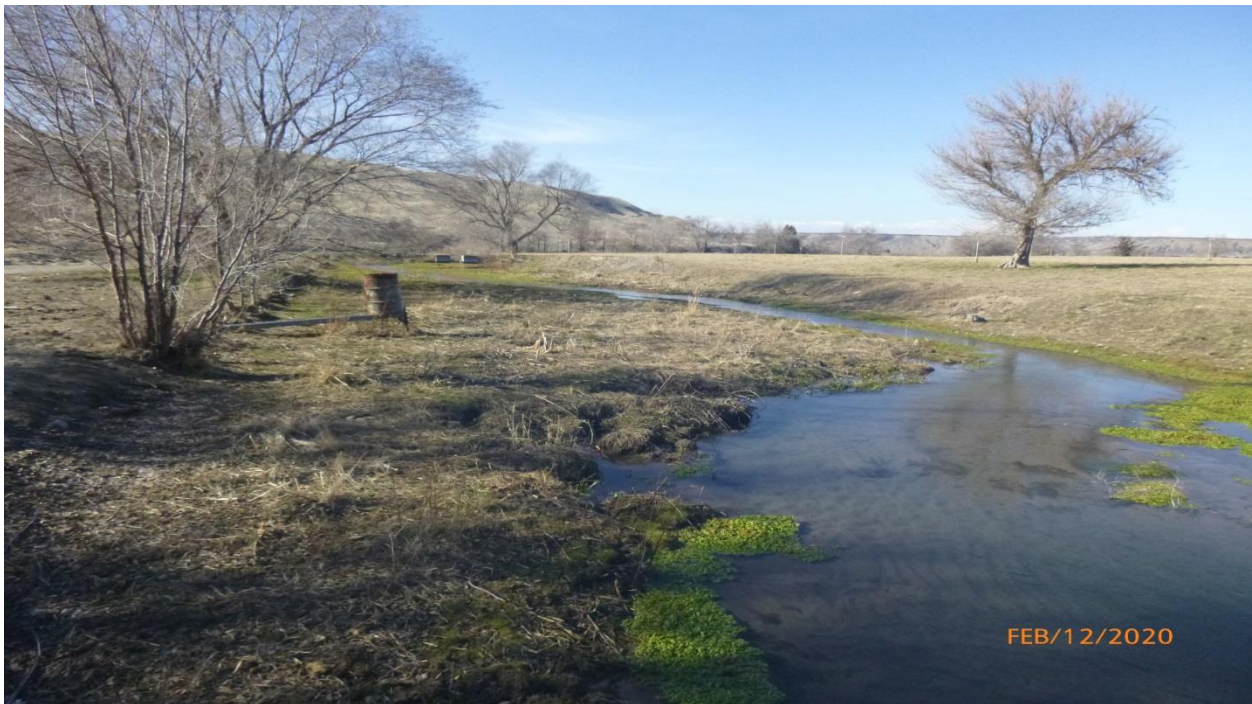
**Photograph 5. Earthen pond #6 and FFSB, facing northwest.**

In the future, Mr. Standal mentioned that he may look into converting the earthen ponds (5 & 6) into concrete raceways with FFSBs.
